Manhole Inspection Summary

Manhole # S43I2_009MH

Location Address: **1200 West Bay Ave.**

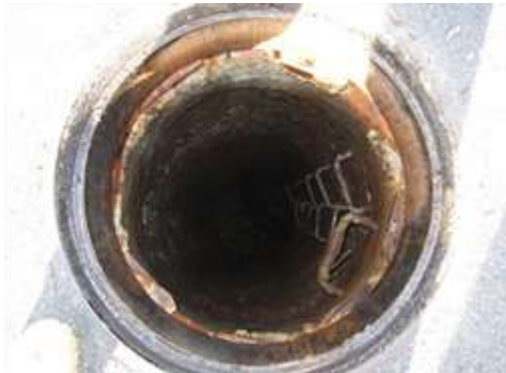
Top View

Correct Pipe In @ 7 O'Clock

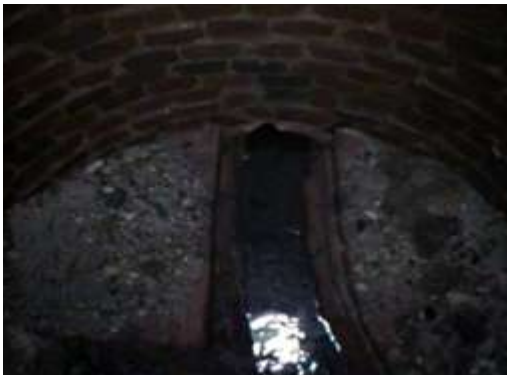
Correct Pipe Out @12 O'Clock

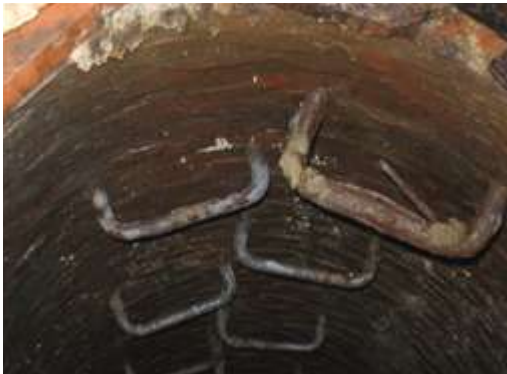
steps

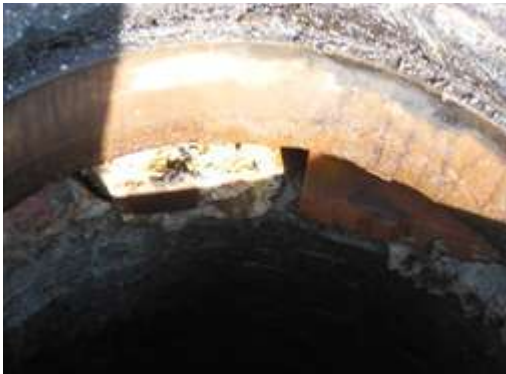
Defect 1

Condition: ☐ Sound ☐ Cracked ☐ Root Intrusion ☒ **Loose Brick** ☐ Deteriorated

loose bricks on chimney

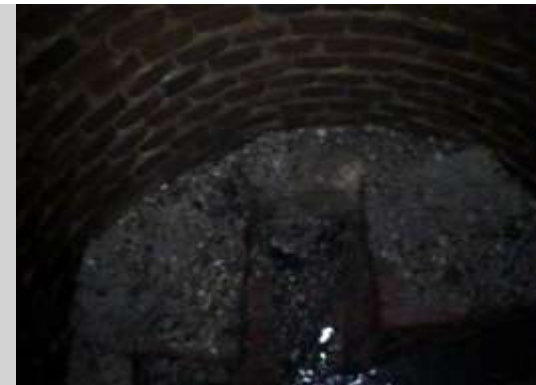
5 O'Clock Inflow

Channel is permanently blocked (Plugged in)

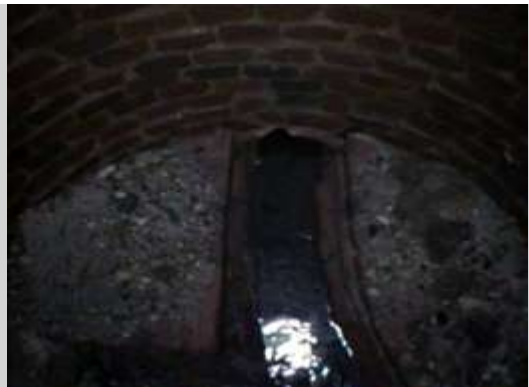
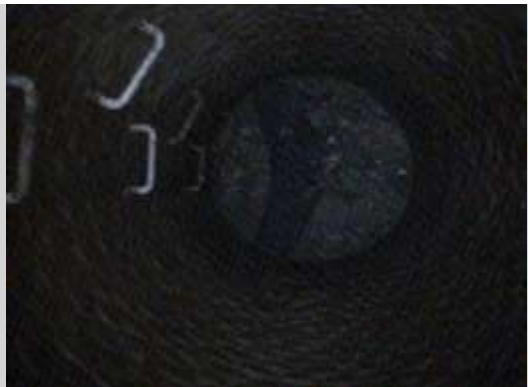
7 O'Clock Inflow

manhole too deep for pole cam pictures
